Lanterns + Foundations

Almost accident with Lanterns

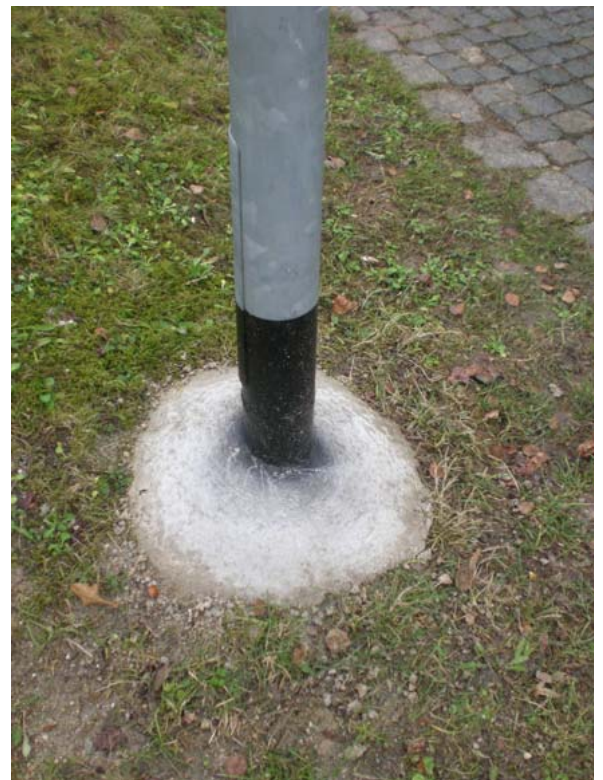
During a conversation **somebody just lightly leaned against a Lantern** that stood on the church property. **The Lantern collapsed** thereafter because it was strongly corroded at the foot-end. Thankfully no one got hit by the falling Lantern.

Afterwards every Lantern was thoroughly investigated. It has become obvious that other Lanterns were also very rusty at bottoms end and not standing securely enough. It has been suggested that the reason for this weakness is the use of salt (winter) combined with a faulty concrete-foundation. **Aggressive brine** was being collected around the Lantern-foot, not flowing off and so causing the damage.

Now during the repairing it was being made sure that the lanterns were receiving a **baffle-painting** and the **concrete-foundations** were being made in such a way that they could not collect rain any more. We recommend you look after your own Lantern and see if they show any similar signs! *As you can see, even fire-zinced metal-stands can corrode gradually.* The bottom-point is especially susceptible and often not in focus, since for instance plants cover up the Lantern-stand on the ground.
